# **SEAMAN CORPORATION**

# Improved Polyurethane Storage Tank Performance

Contract No. SP0600-04-D-5442, Delivery Order 1017

# FY2008 Final Report Revision 3

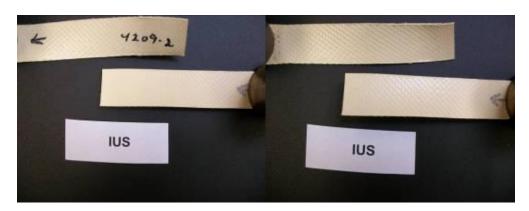
# 5.5.1.2.1 IUS – Interply Urethane Separation

IUS – Interply Urethane Separation – the separation occurred between the two inner urethane layers between the weld seam. In some cases, an inadequate "cold weld" possibly occurred.

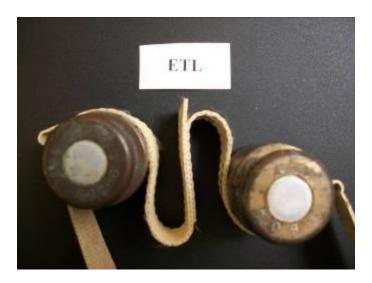
### 5.5.1.3.1 ETL – End Tab Lift

ETL – End Tab Lift – the edge of the weld on one or both pieces, separates from the seam area from the edge, inward.

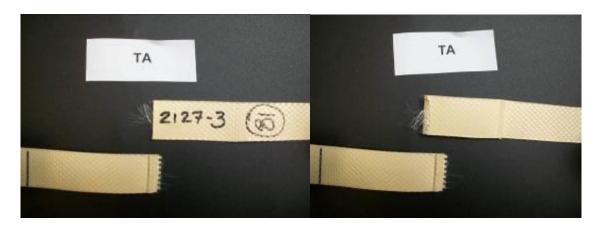
## 5.5.1.4.1 TA – Tore Adjacent to Weld

TA – Tore Adjecent to Weld – the material on one piece tears parallel to the edge of the welded seam. A complete TA is shown below.

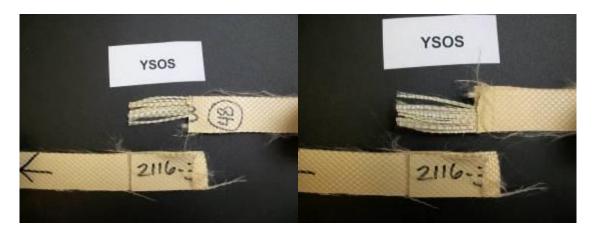
## 5.5.1.4.3 YSOS – Yarns Stripped-Out of Seam

YSOS – Yarns Stripped-Out of Seam – some or all of the yarns are completely or partially pulled out of the weld area.
